Appendix 5

Photograph Log and Photographs

Photograph Log

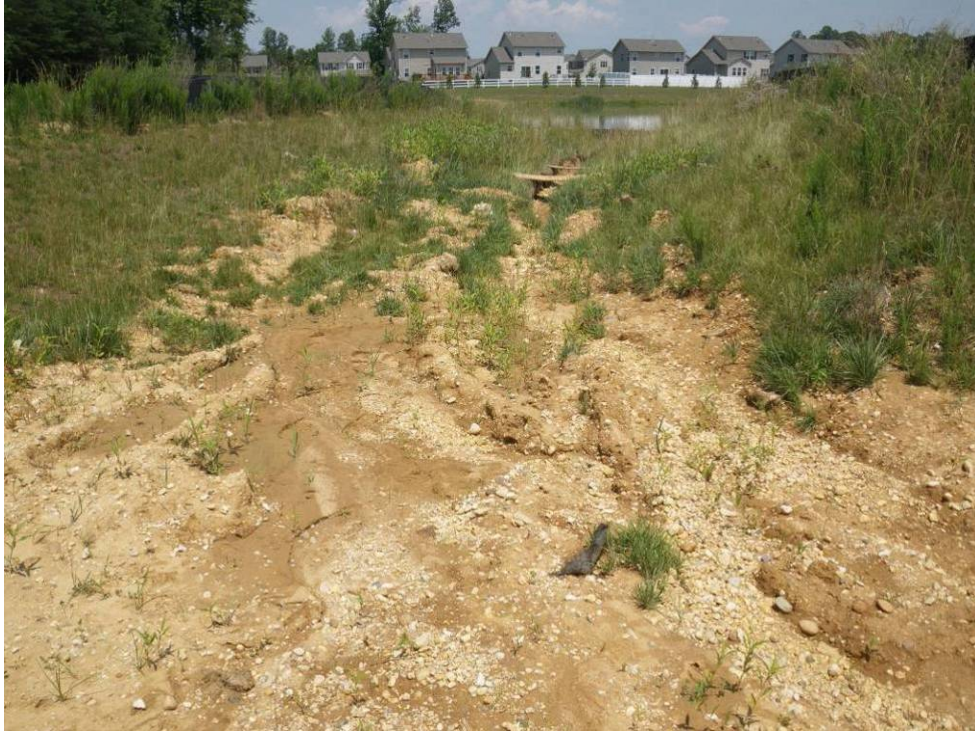
Photograph 1. **New High School Construction Site: Overall view of swale to Basin A.**

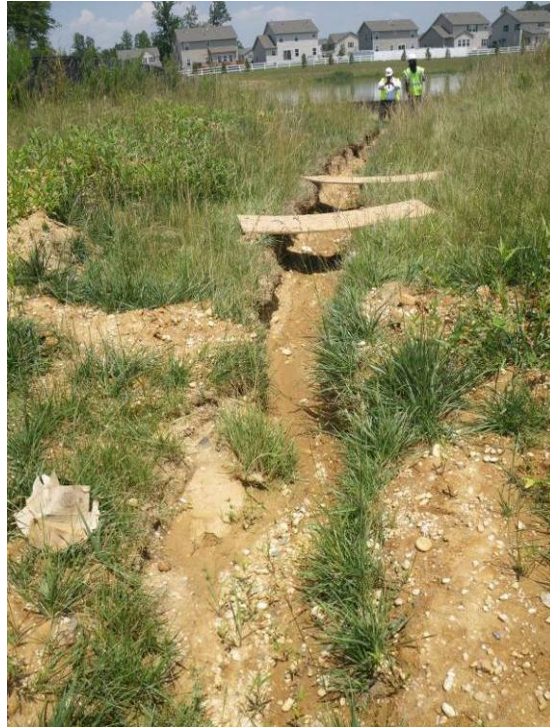
Photograph 2. **New High School Construction Site: Close up view of eroded area of swale shown in Photograph 1.**

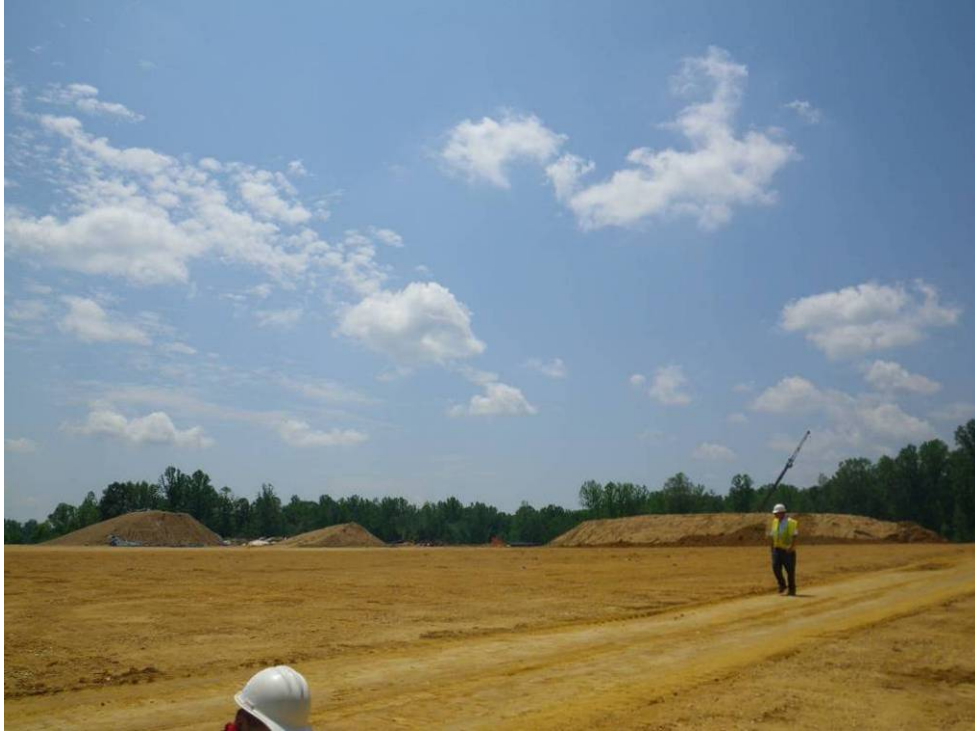
Photograph 3. **New High School Construction Site: Multiple unstabilized, uncovered stockpiles located on site.**

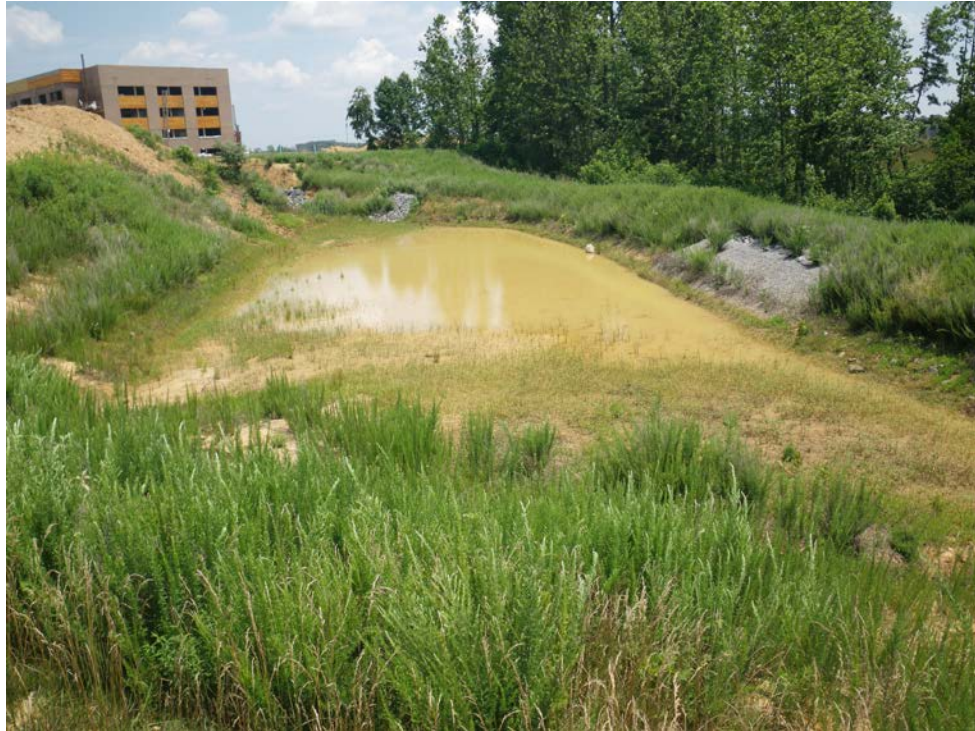
Photograph 4. **New High School Construction Site: Unstabilized stockpile located adjacent to Sediment Trap 2, on the left side of the photograph..**

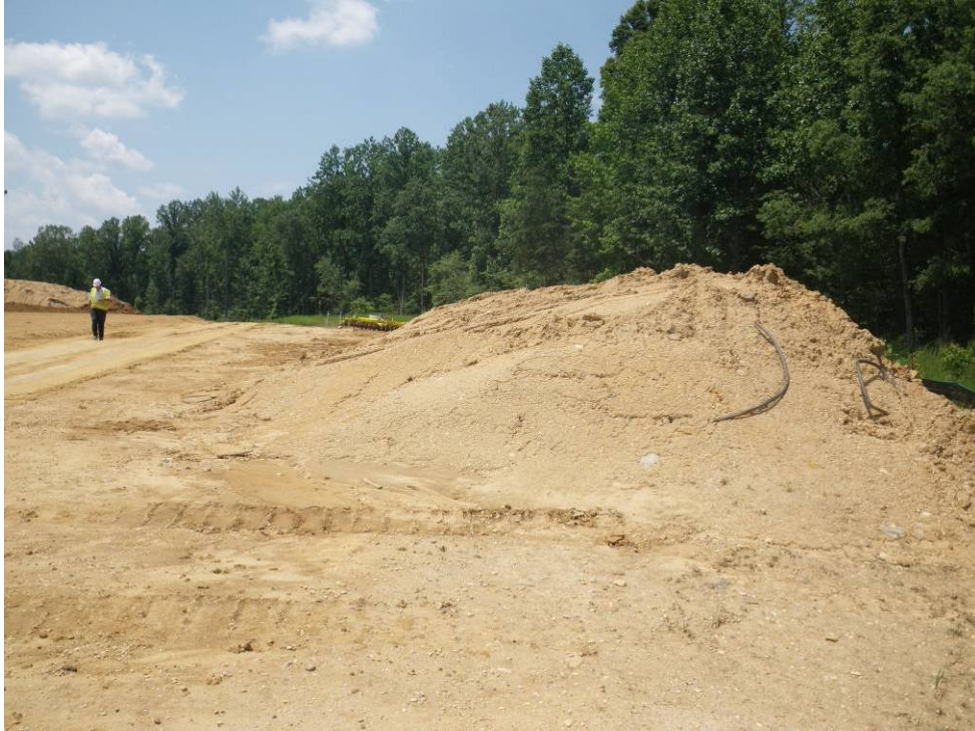
Photograph 5. **New High School Construction Site: Unstabilized, uncovered stockpile located near the perimeter of the site.**

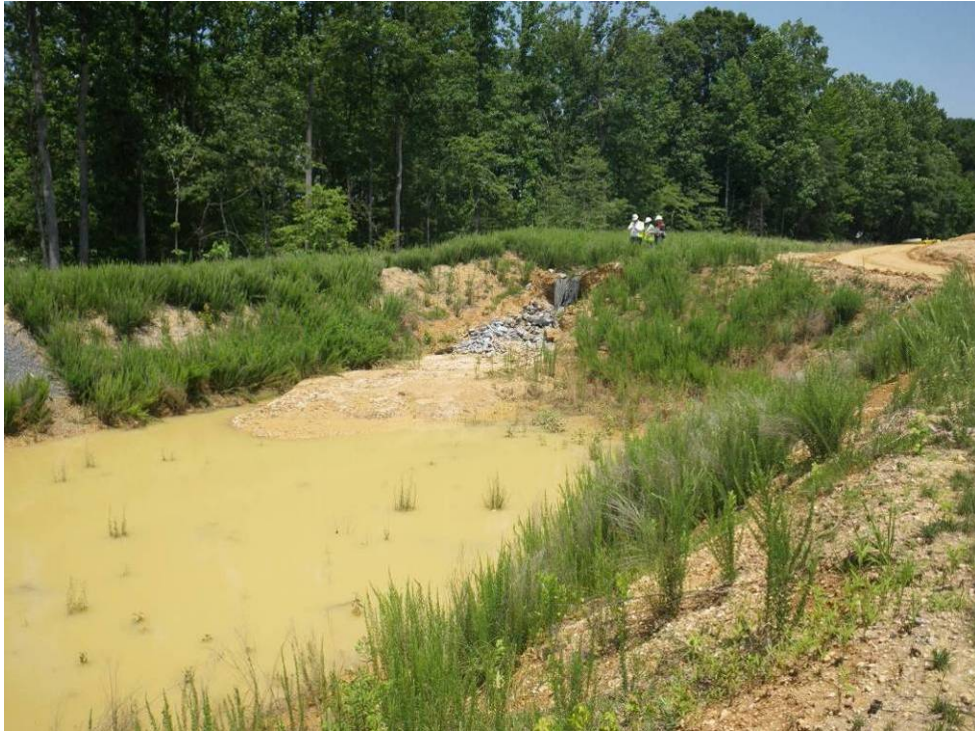
Photograph 6. **New High School Construction Site: Collapsed inflow point from eastern swale to Sediment Trap 3.**

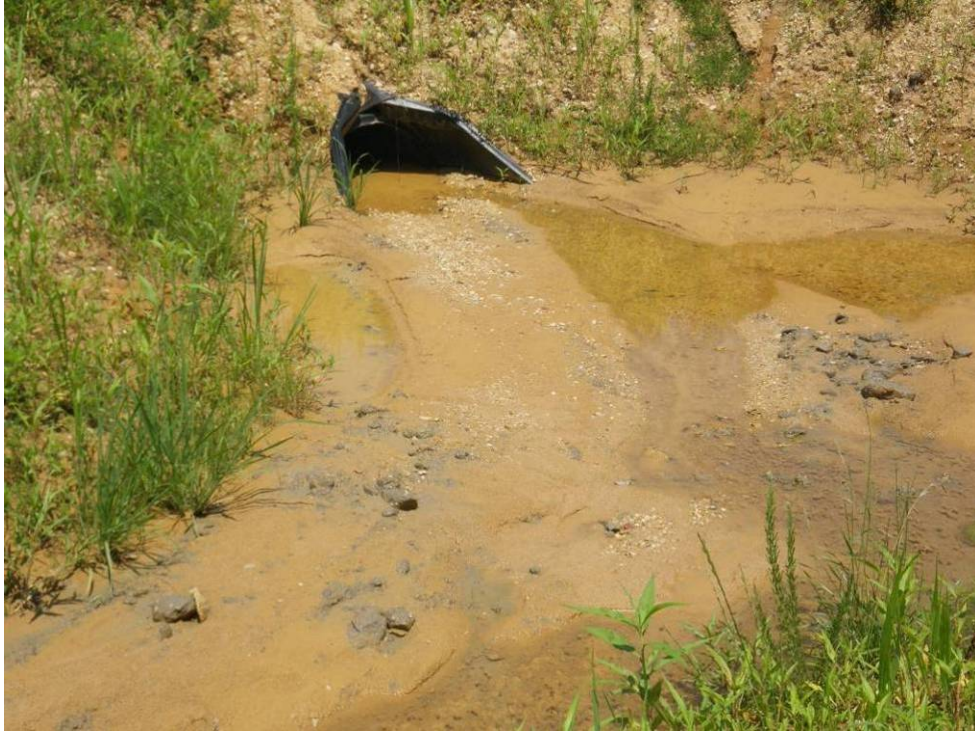
Photograph 7. New High School Construction Site: Eroded area of eastern swale to Sediment Basin 1.

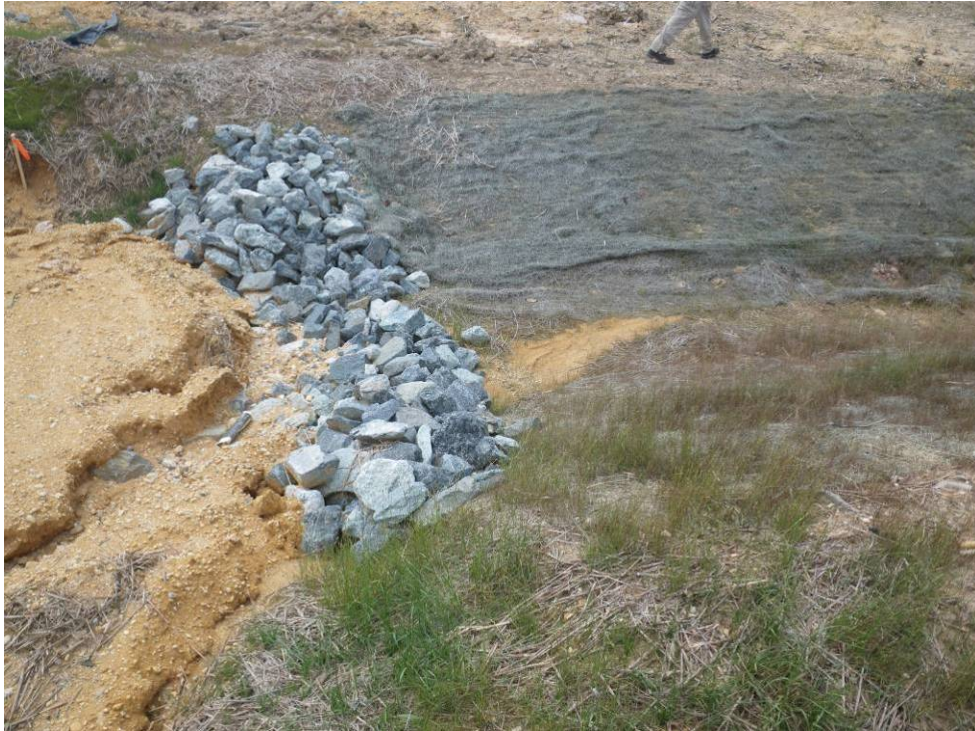
Photograph 8. Fieldside Parcels C&E Construction Site: Sediment accumulation present on the riprap and in the eastern swale leading to Sediment Trap 1.

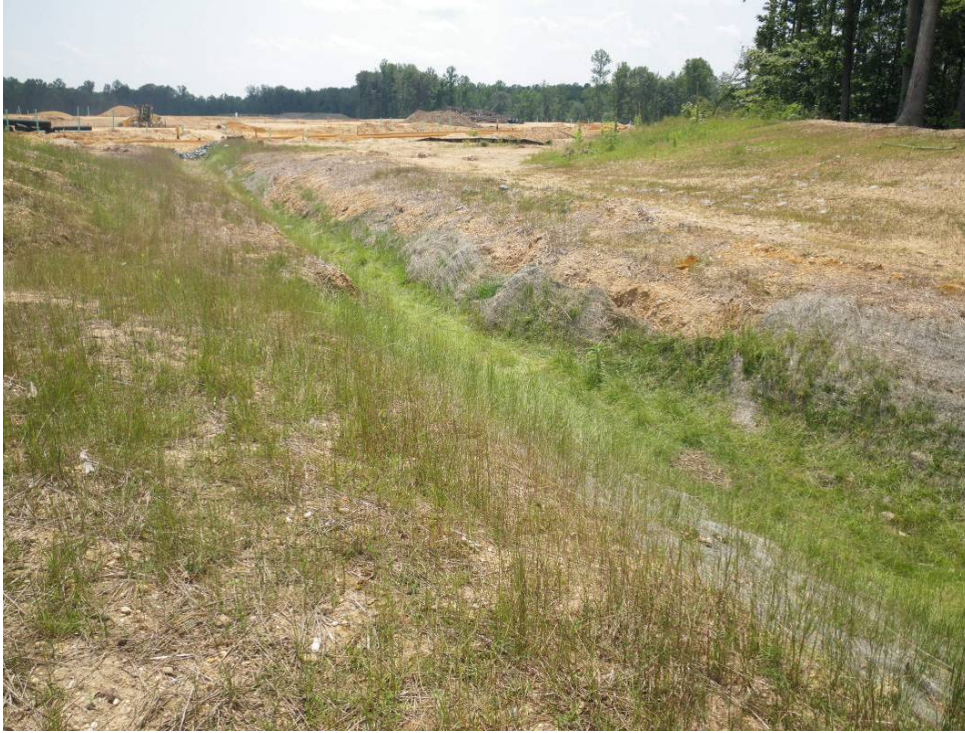
Photograph 9. **Fieldside Parcels C&E Construction Site: Unattached matting and erosion in western swale leading to Sediment Trap 1.**

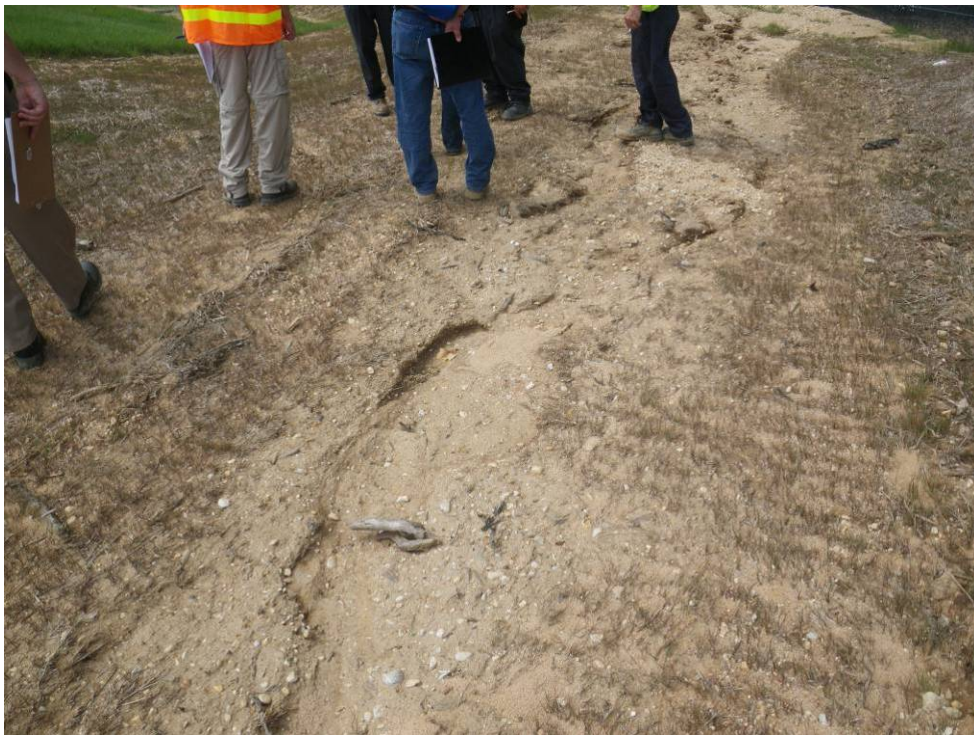
Photograph 10. **Fieldside Parcels C&E Construction Site: Downslope view of unstabilized swale leading toward the northern edge of the site. Erosion rills are visible.**

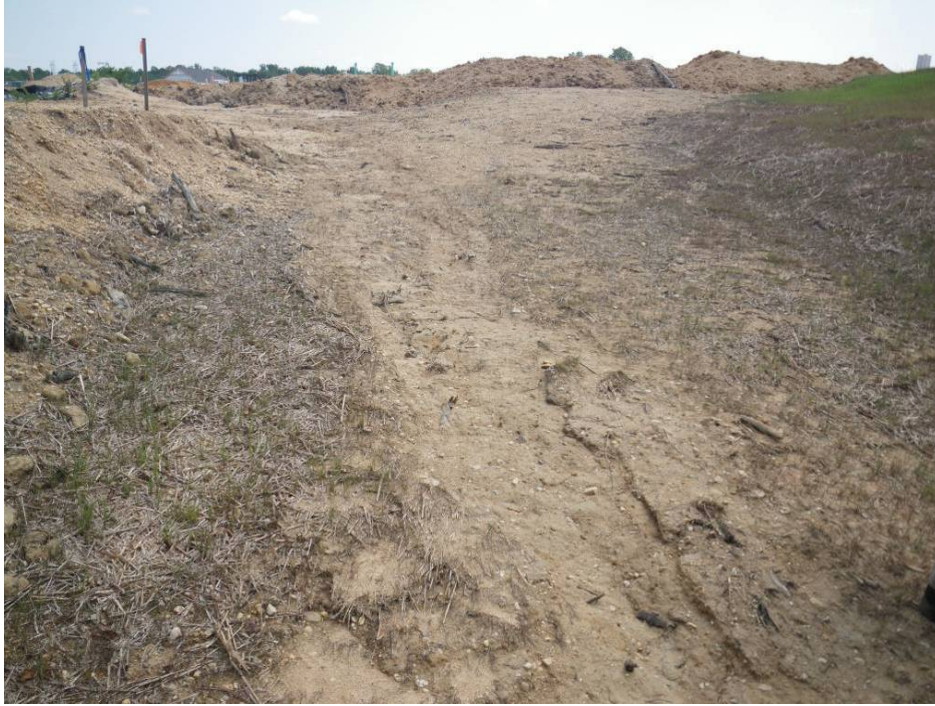
Photograph 11. Fieldside Parcels C&E Construction Site: Upslope view, looking into construction site, of unstabilized swale leading toward the northern edge of the site. Erosion rills are visible.

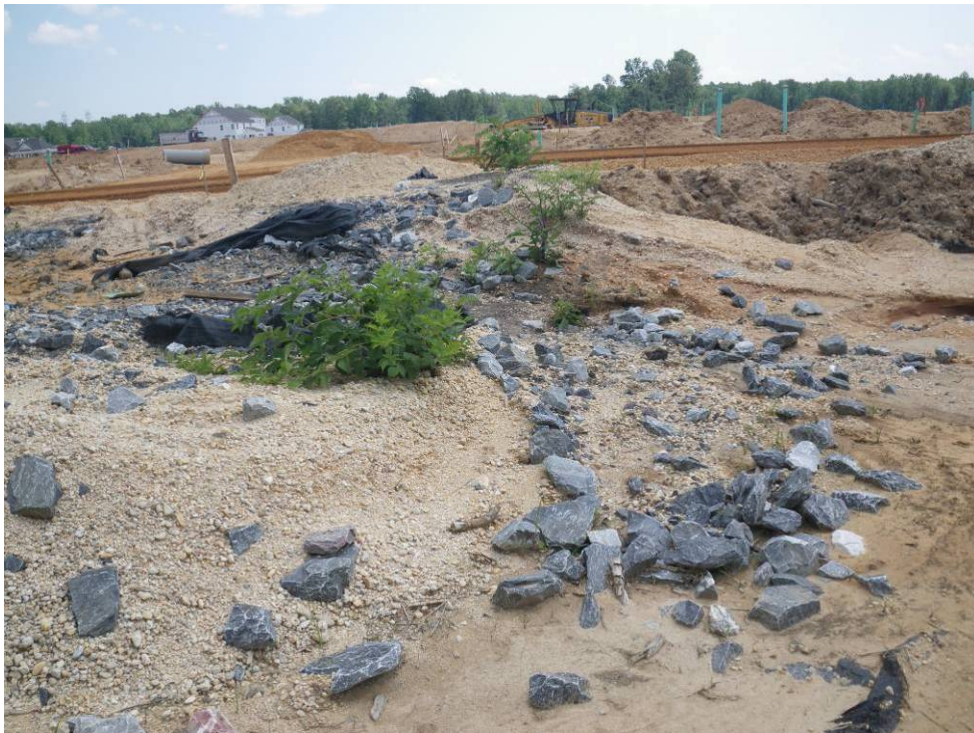
Photograph 12. Fieldside Parcels C&E Construction Site: Displaced riprap and sediment accumulation near swale shown in Photographs 10 and 11.

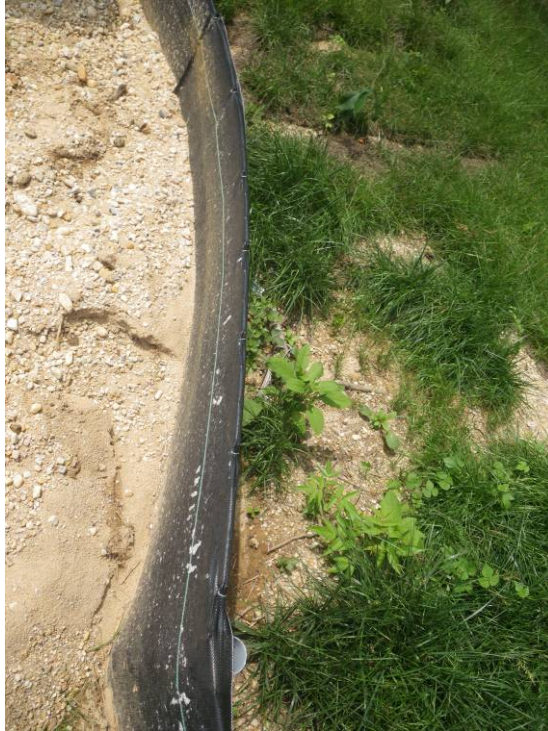
Photograph 13. **Fieldside Parcels C&E Construction Site: Sediment accumulation outside of silt fence near the bottom of swale shown in Photographs 10 and 11.**

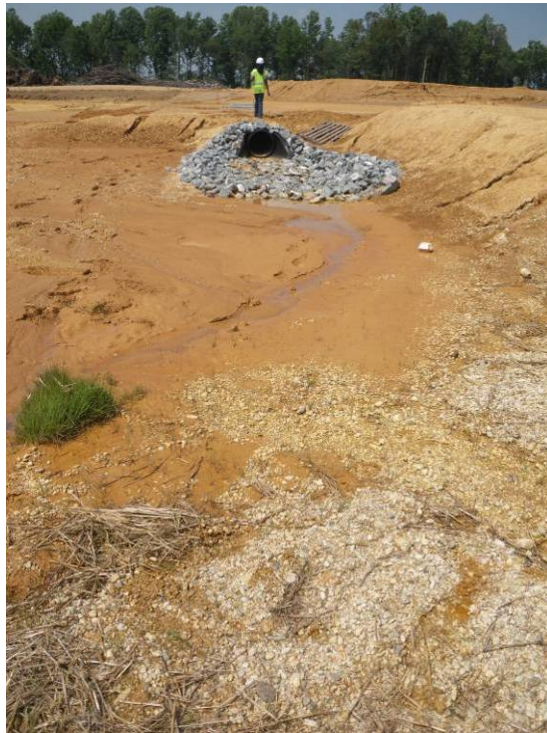
Photograph 14. **Fieldside Parcels C&E Construction Site: Inlet area of unstabilized swale leading to Existing Sediment Basin 2/Pond 5. Erosion is visible.**

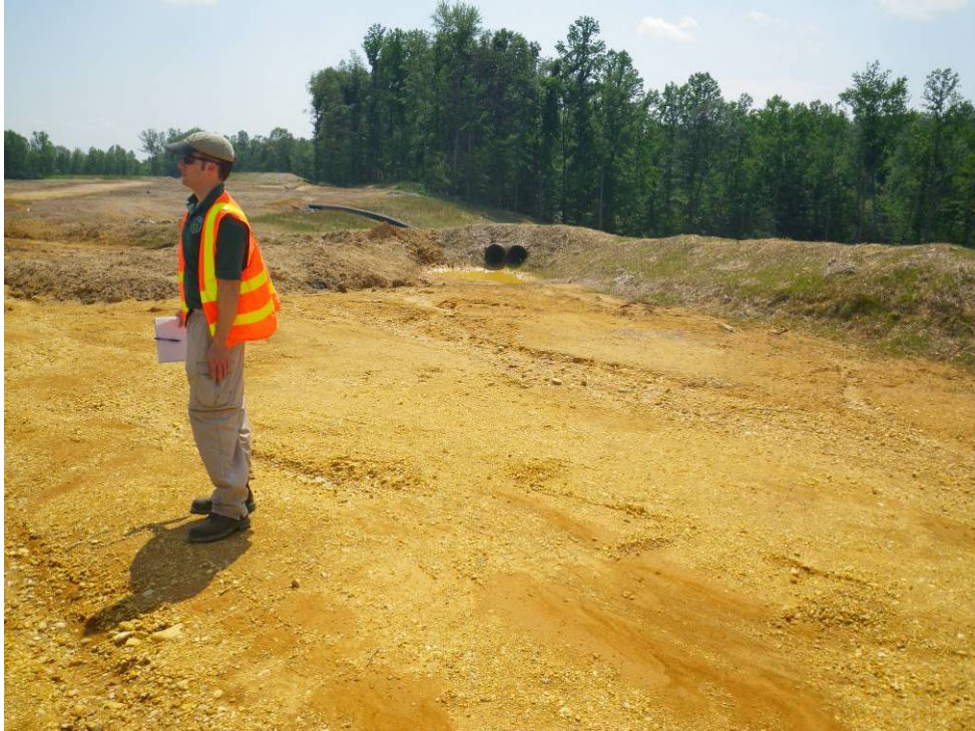
Photograph 15. Fieldside Parcels C&E Construction Site: Area of swale in Photograph 14 near slope drain to Existing Sediment Basin 2/Pond 5.

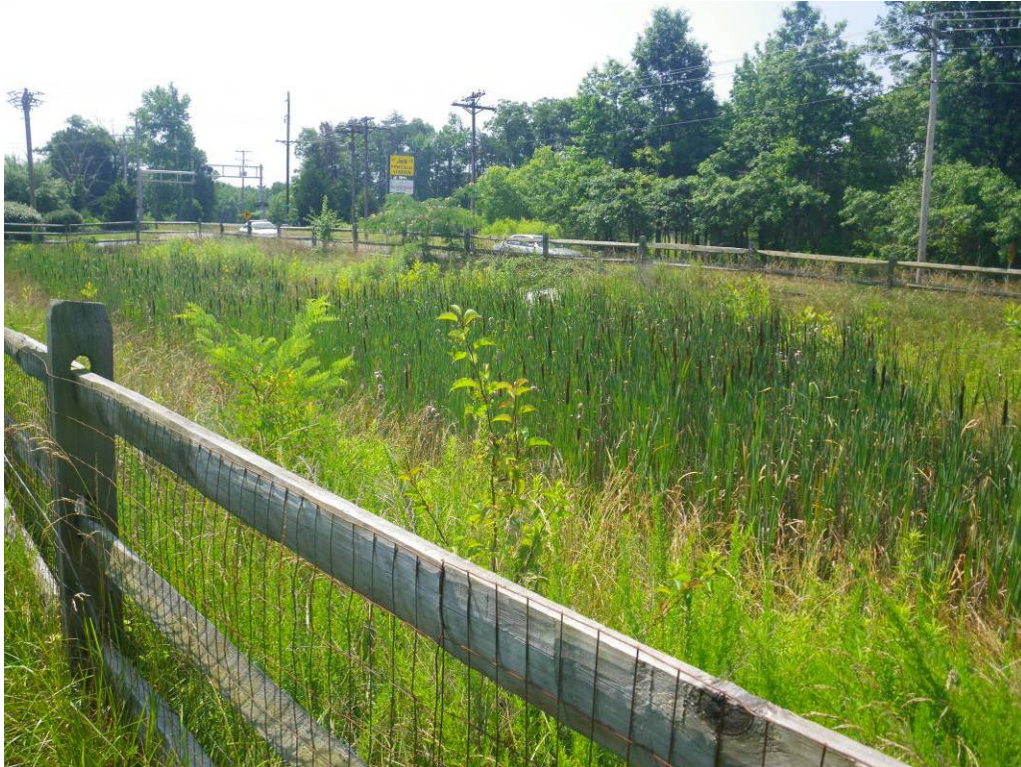
Photograph 16. Truck’N America: Overgrown vegetation in the dry pond.

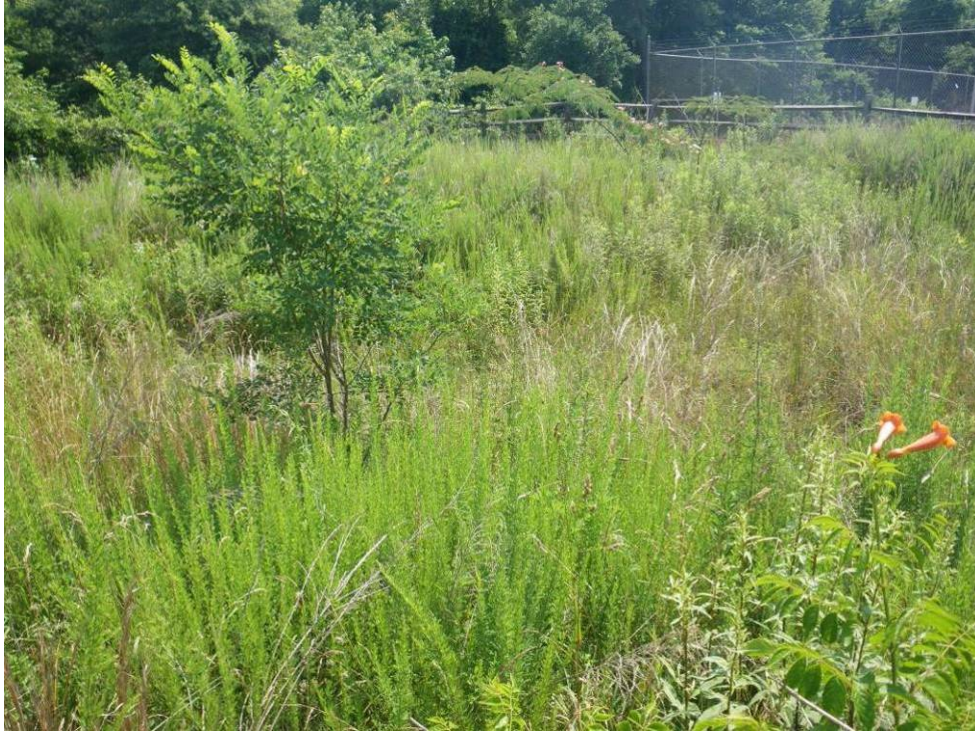
Photograph 17. Truck’N America: Overgrown vegetation and trees in the dry pond.

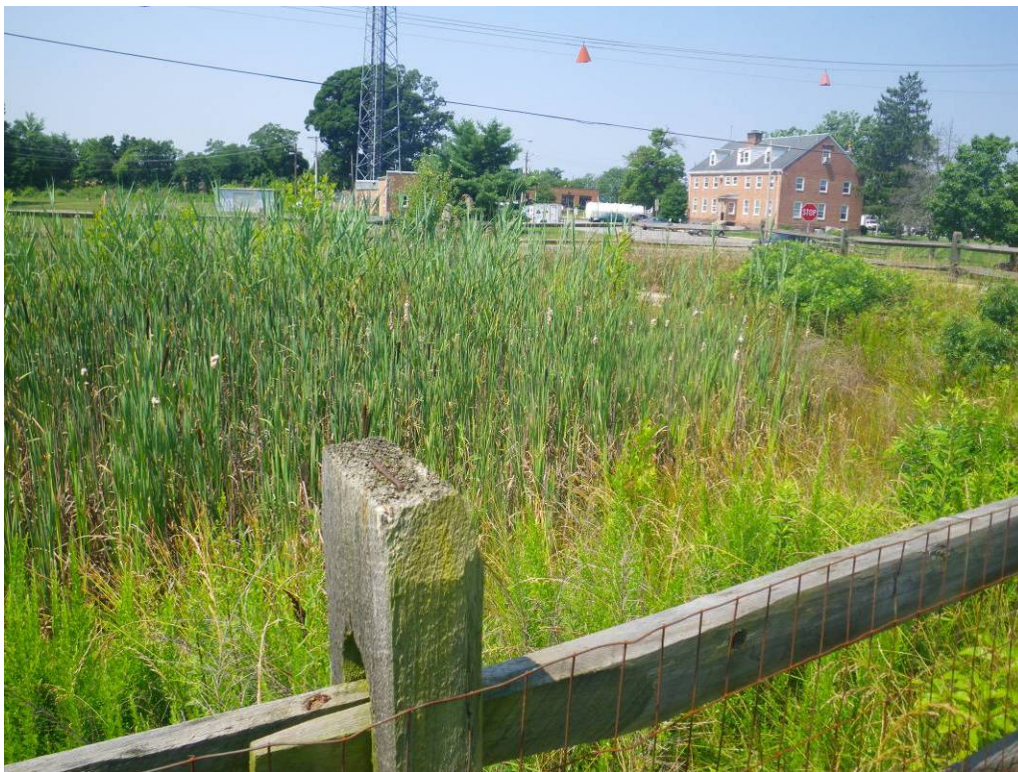
Photograph 18. Truck’N America: Overgrown vegetation in the dry pond.

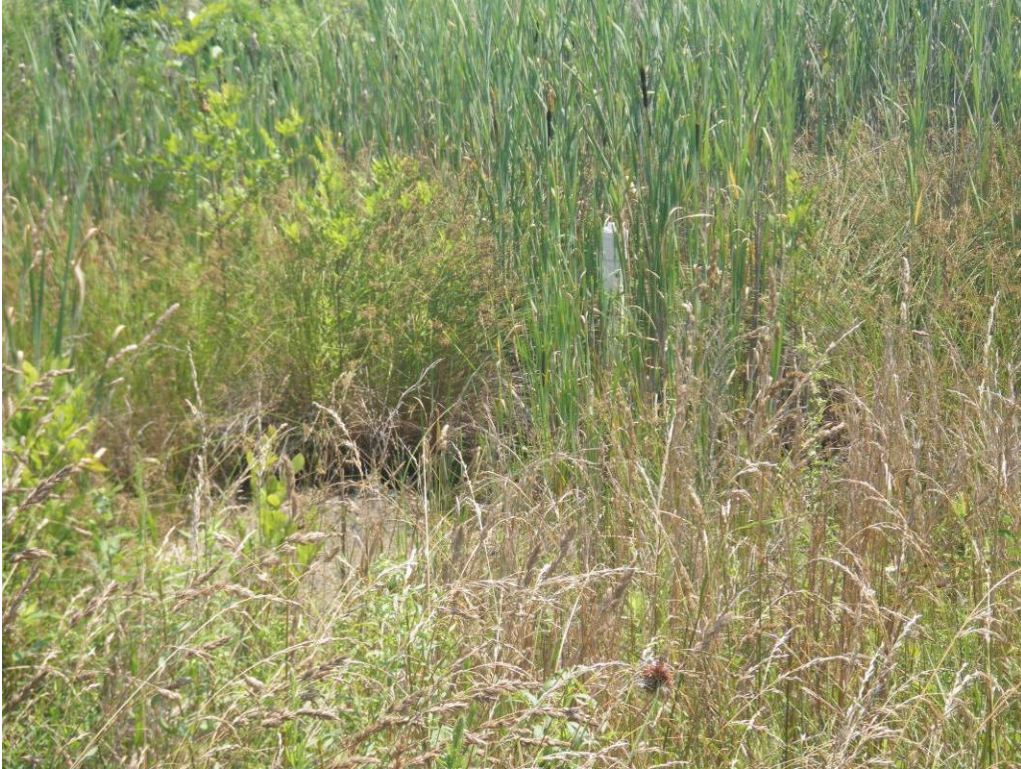
Photograph 19. Truck’N America: Overgrown vegetation in the dry pond.

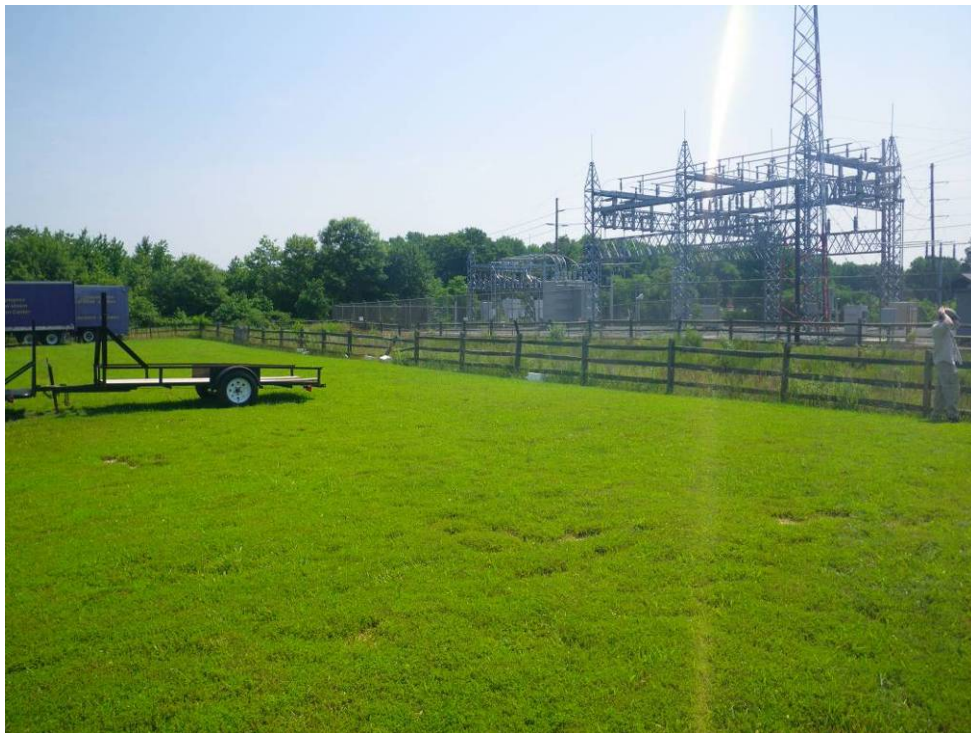
Photograph 20. Truck’N America: Damaged fence in the background.

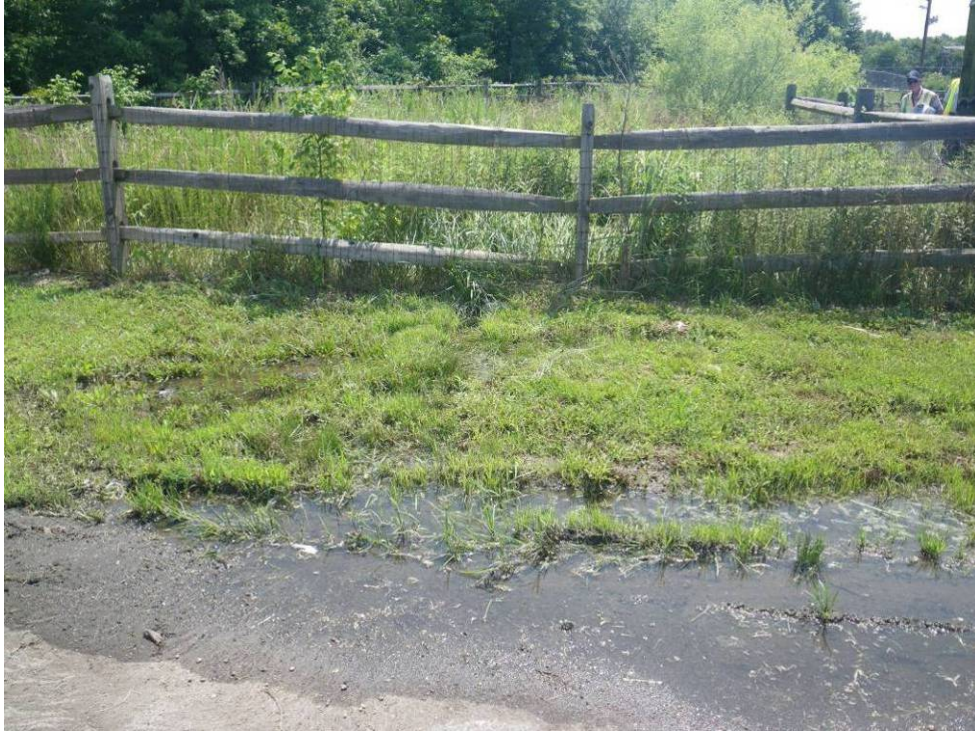
Photograph 21. Truck’N America: Water pooling and not draining into the dry pond.

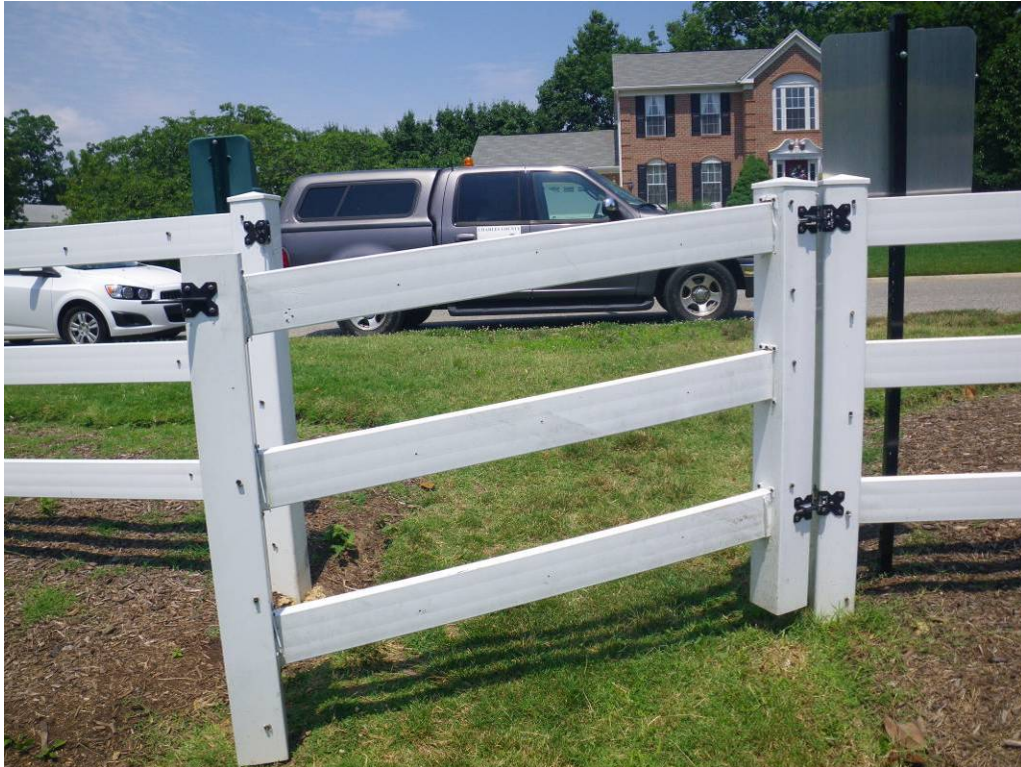
Photograph 22. Ashford Oaks: Fence with a broken latch.

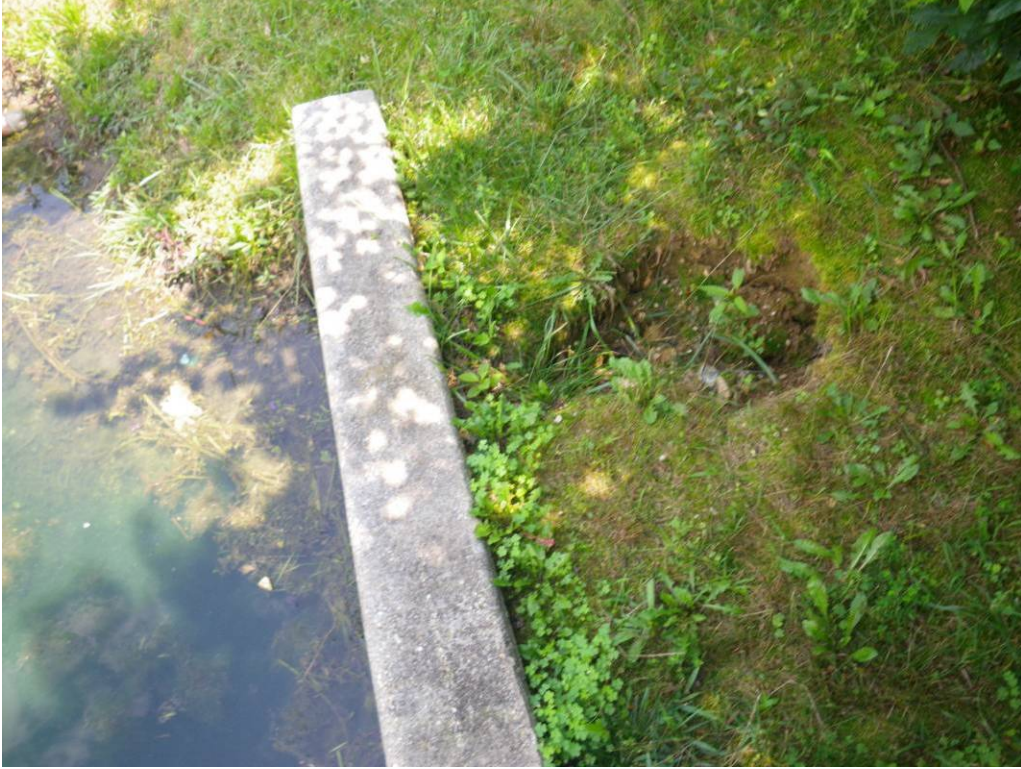
Photograph 23. Ashford Oaks: Erosion on the banks of the pond near an inlet.

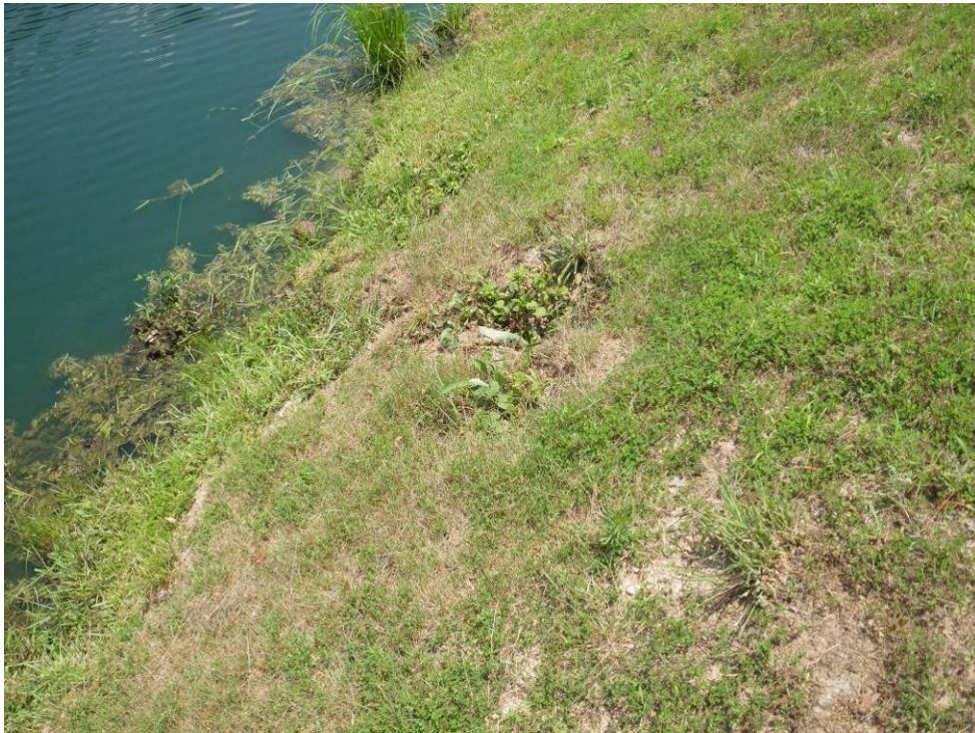
Photograph 24. Ashford Oaks: Bare spots and erosion along the banks of the wet pond.

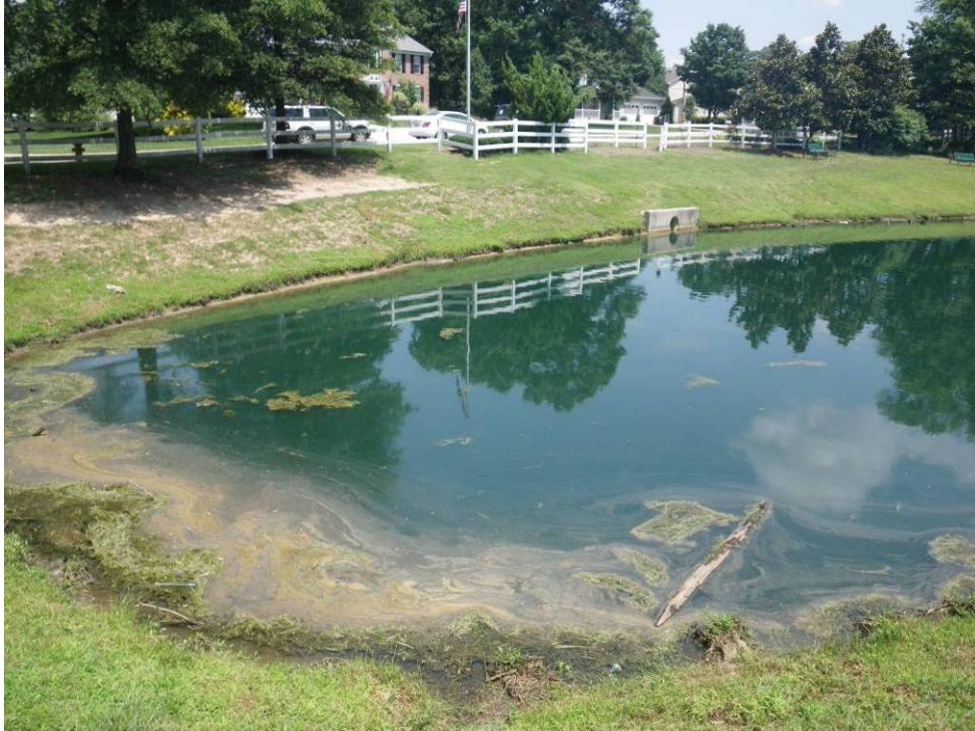
Photograph 25. Ashford Oaks: Bare spots and erosion along the banks of the wet pond.

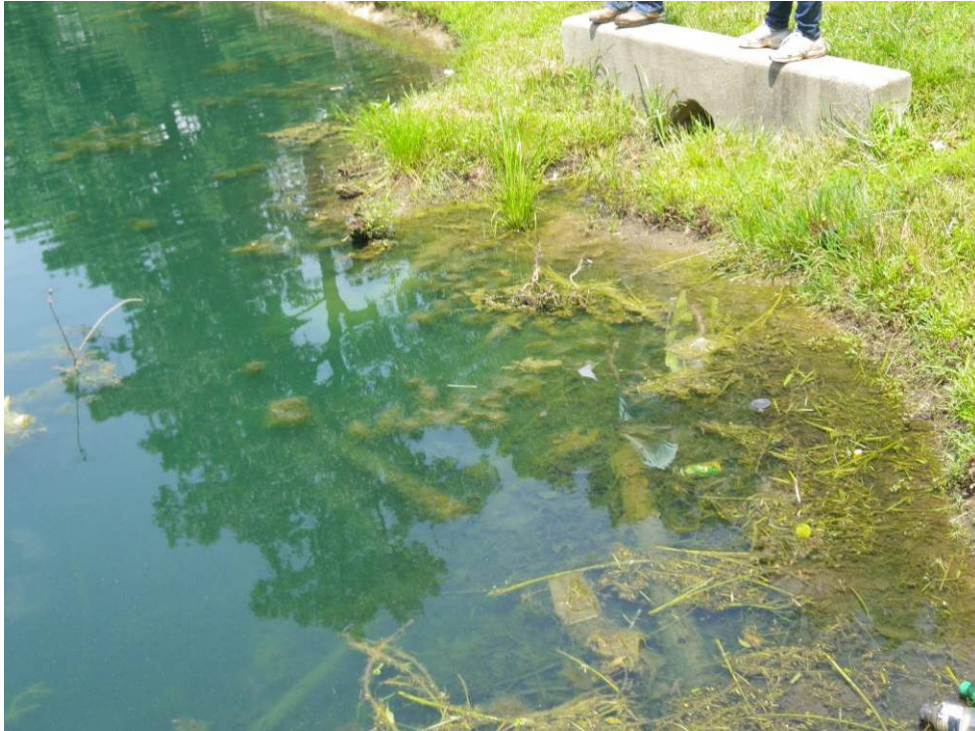
Photograph 26. Ashford Oaks: Sediment accumulation in front of an inlet structure.

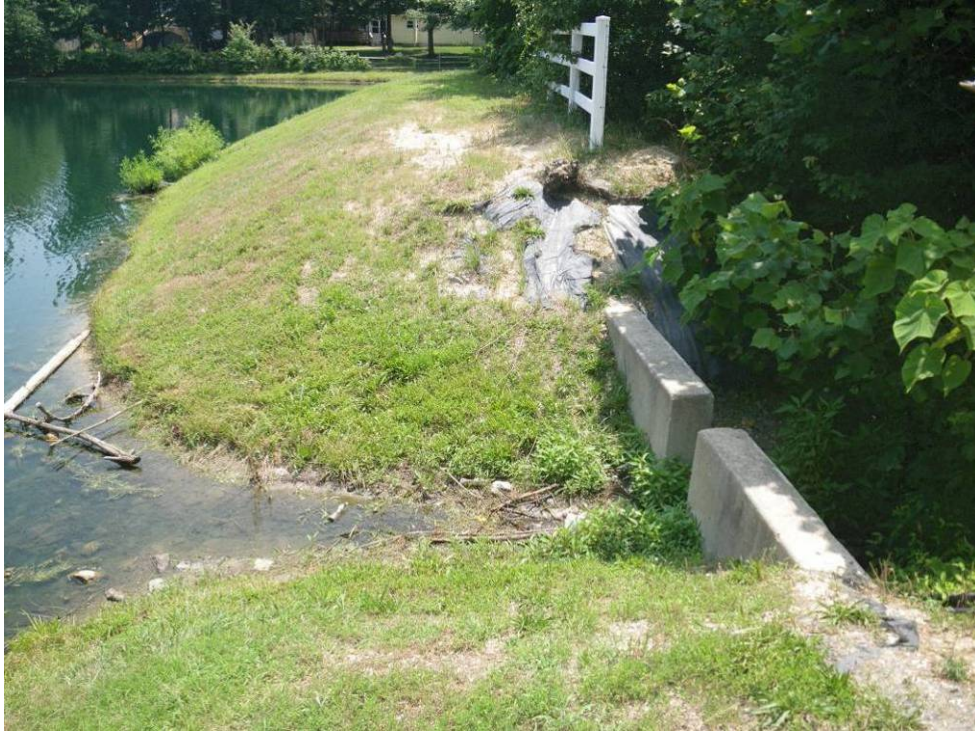
Photograph 27. Ashford Oaks: Sediment accumulation in the conveyance area in front of the weir wall.

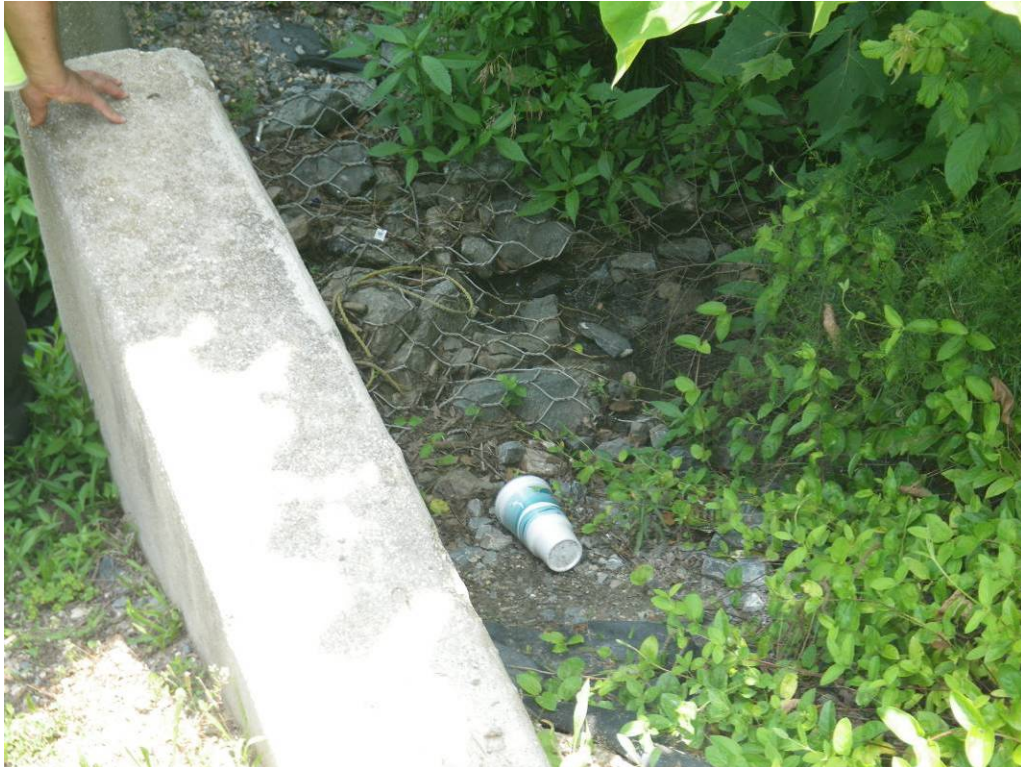
Photograph 28. Ashford Oaks: Debris by the weir wall.

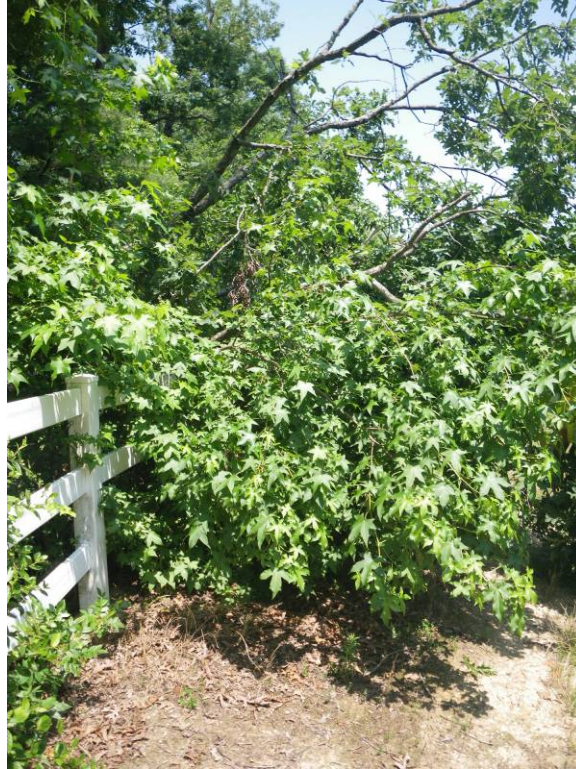
Photograph 29. Ashford Oaks: Overgrown trees and vegetation.

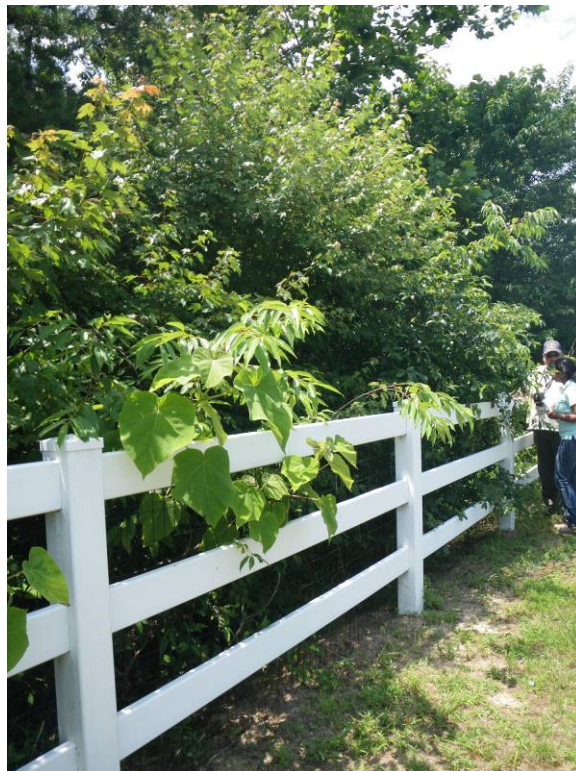
Photograph 30. Ashford Oaks: Overgrown trees and vegetation.

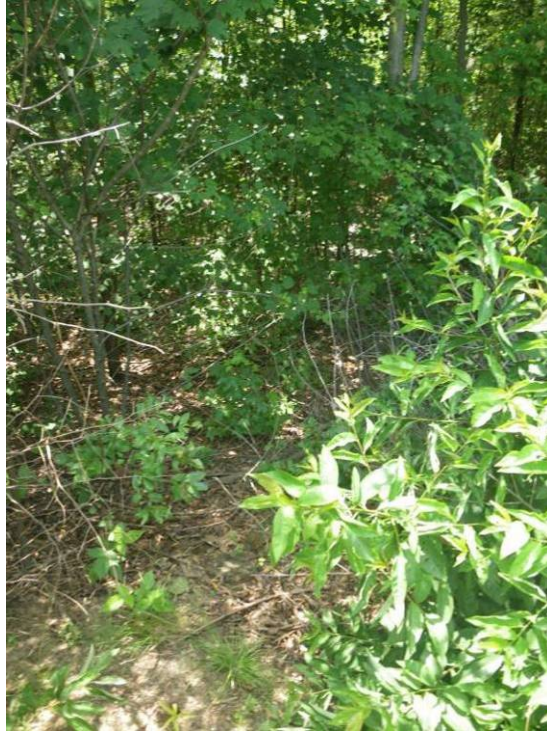
Photograph 31.

Ashford Oaks: Overgrown vegetation on the slope behind the weir wall.

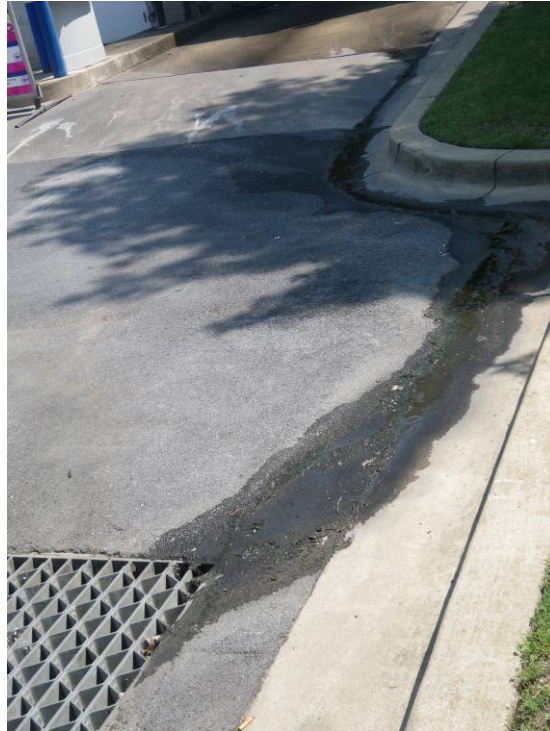
Photograph 32.

Outfall 26 - Speedy Clean Car Wash: Illicit discharge entering storm drain.

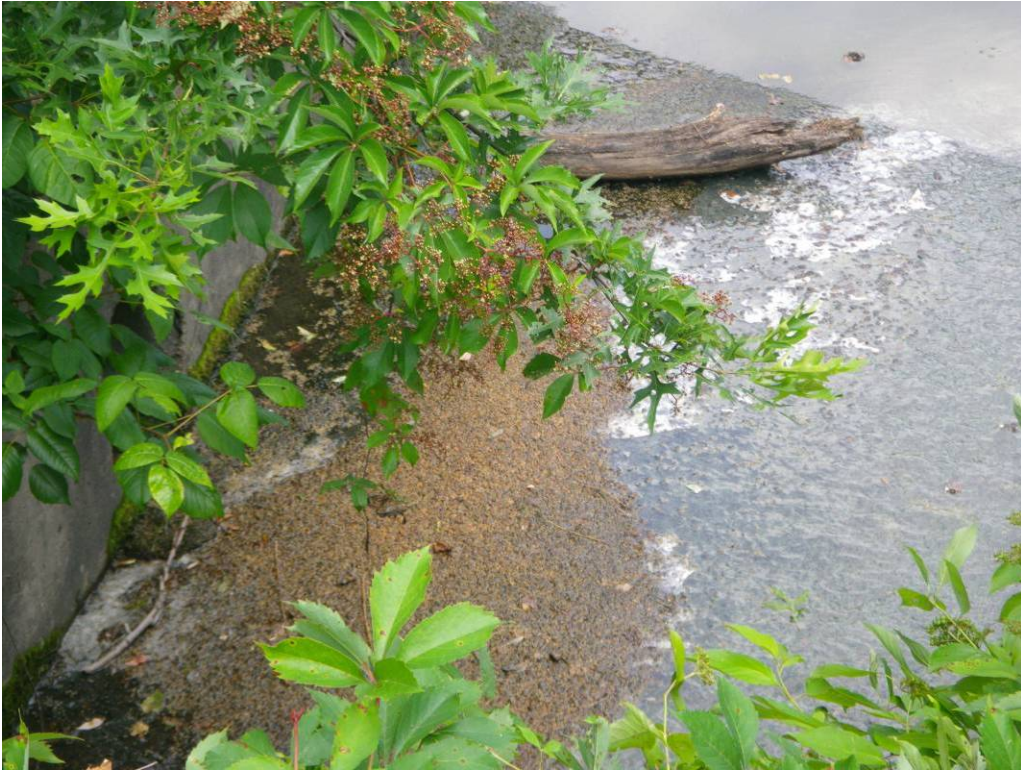
Photograph 33. Outfall 56: White residue at Outfall 56.
